LSU
AgCenter
Research & Extension

VEAL CALF BARN		
PA '88	6412	SHEET OF

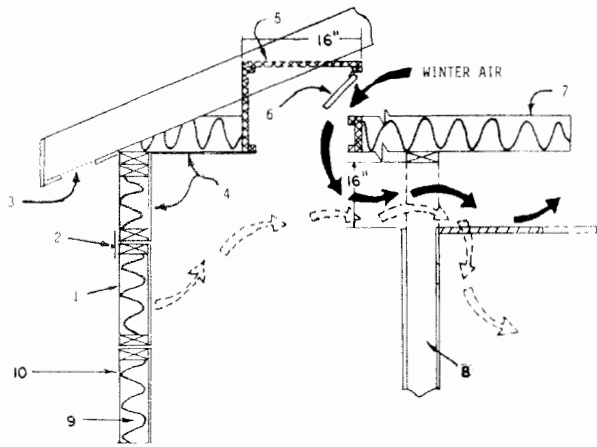
ROOM END AIR INLET DETAIL

- 1 INSULATED SUMMER VENT DOOR 1- 2'x5' DOOR/EACH ROOM
- 2 HINGE
- 3 ATTIC AIR INLET
1/2" SQUARE MESH.
- 4 3/8" EXTERIOR PLYWOOD OVER 4 MIL. PLASTIC
- 5 SERVICE ALLEY AIR INLET BOX (PLYWOOD FRAME)
- 6 EXTRUDED POLYSTYRENE BAFFLE 1"x16" BLUE STYROFOAM SELF ADJUSTING AIR INLET 48" LONG BETWEEN TRUSSES
- 7 8" FIBERGLASS INSULATION
- 8 2"x4" INNER STUD WALL.
- 9 4" INSULATED OUTER WALL
- 10 STEEL SIDING (HORIZONTAL)

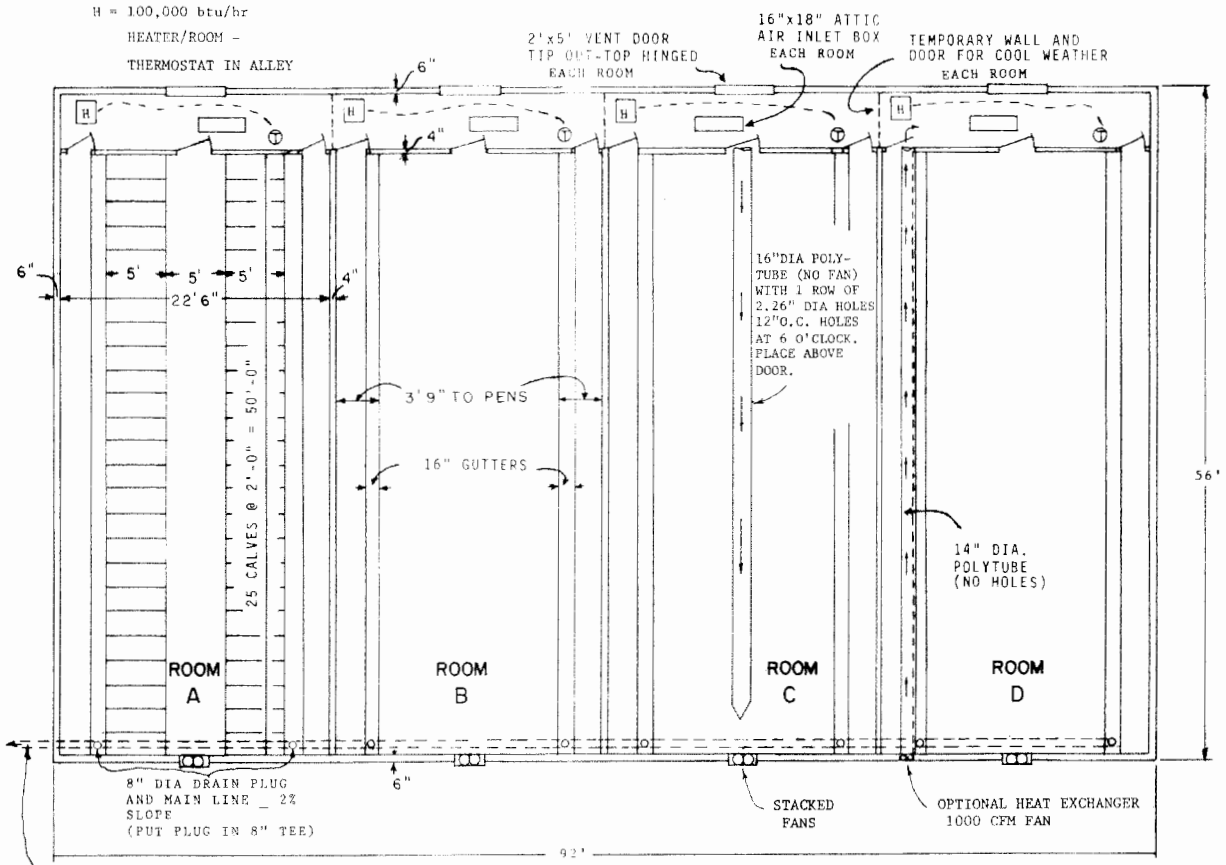
TO MANURE STORAGE
(ALLOW 4-5 GAL/CALF/DAY)
2% SLOPE

NOTE: ALL ROOMS HAVE THE SAME FEATURES.
FEATURES ARE EMPHASIZED AS FOLLOWS:

- ROOM A - PENS
- ROOM B - GUTTERS
- ROOM C - VENTILATION
- ROOM D - HEAT EXCHANGER
